## EVALUATION

**GMN V-100 Cartridge Spindle**

## FINAL INSPECTION REPORT

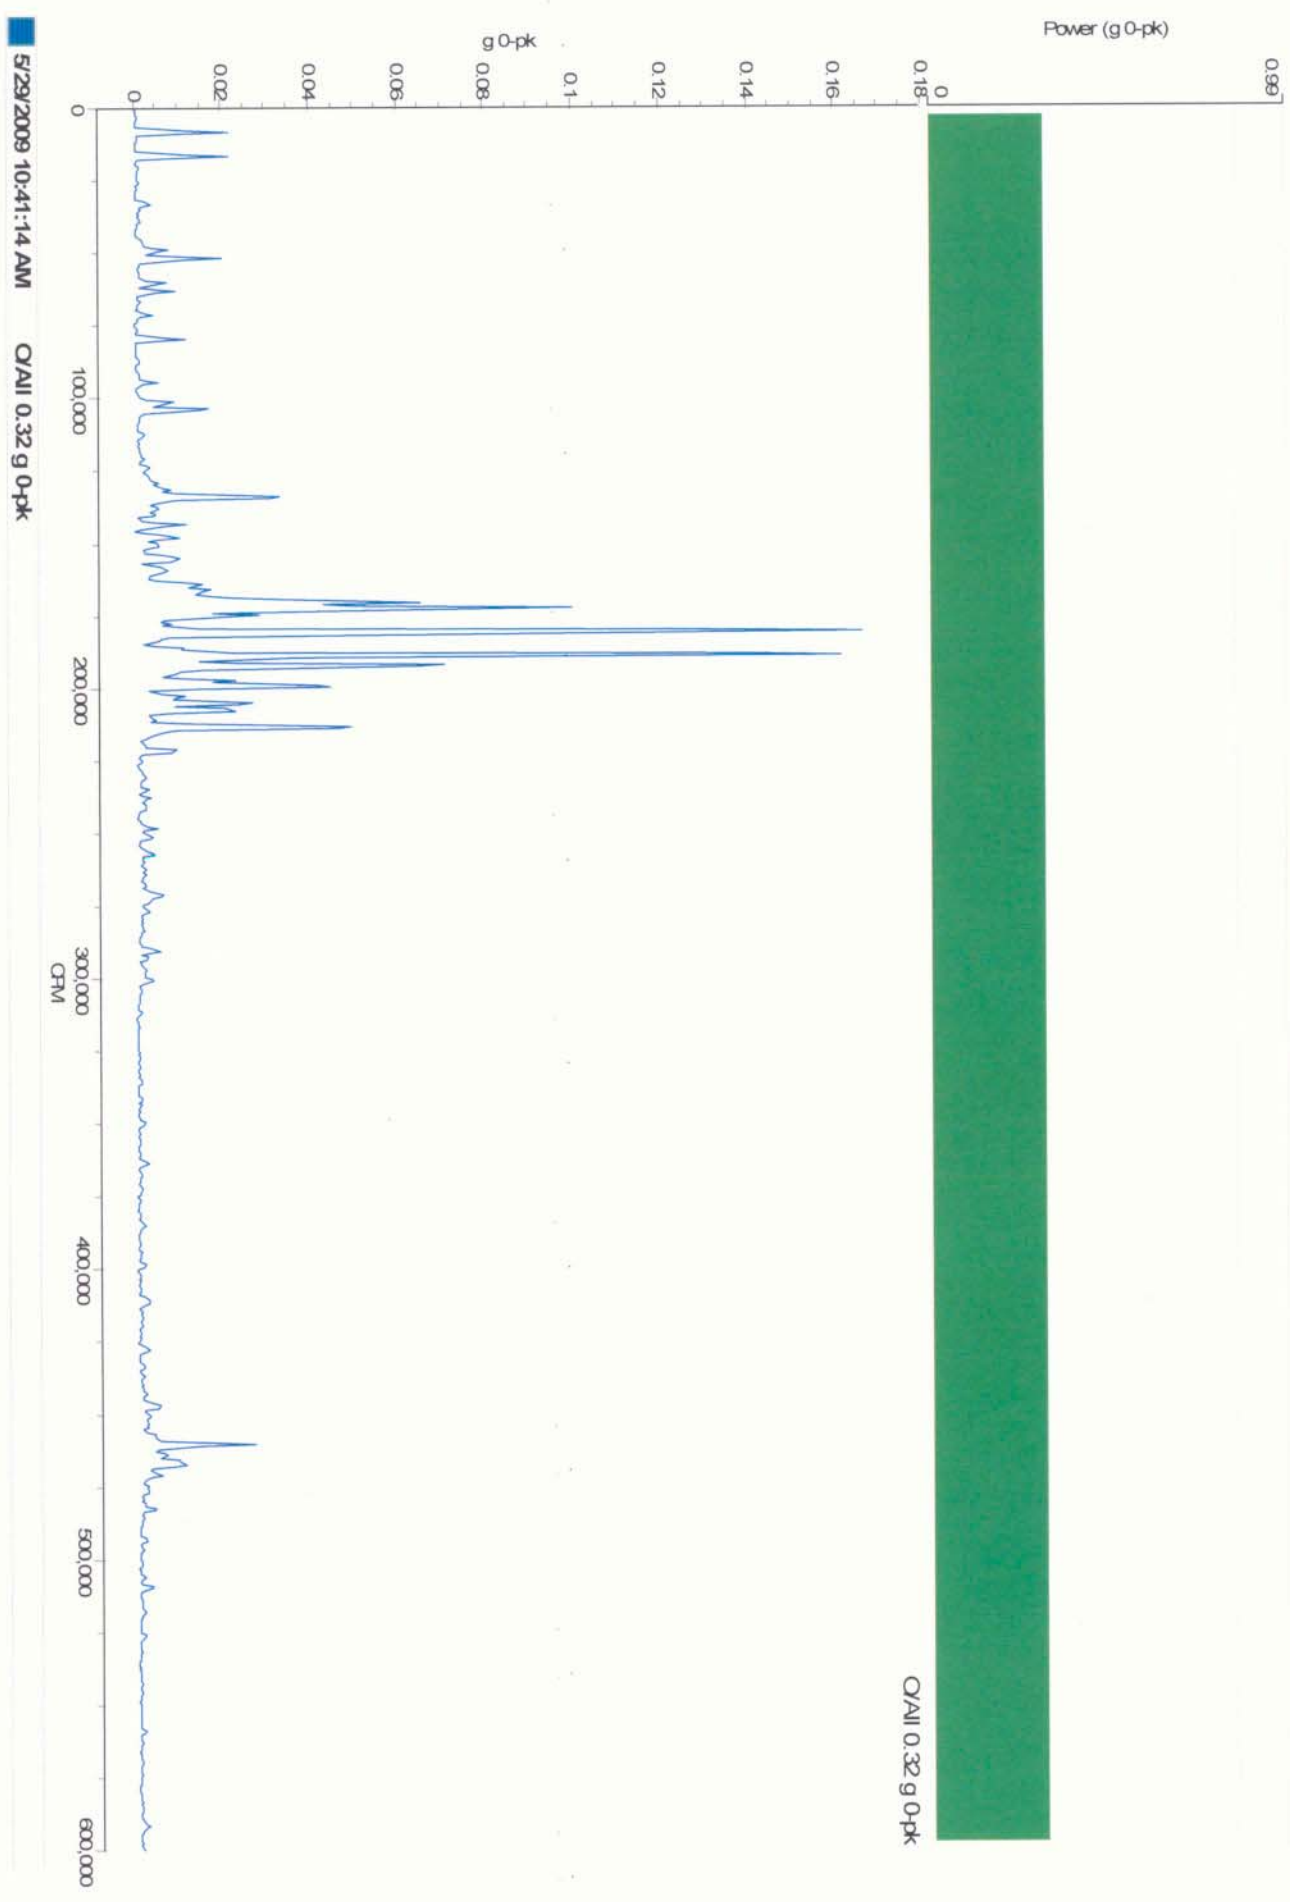
2460341 - Nose - Vertical - Acc Freq 600000 CPM  
5/29/2009 10:41:14 AM

5/29/2009 10:41:14 AM Q/AII 0.32 g 0-pk

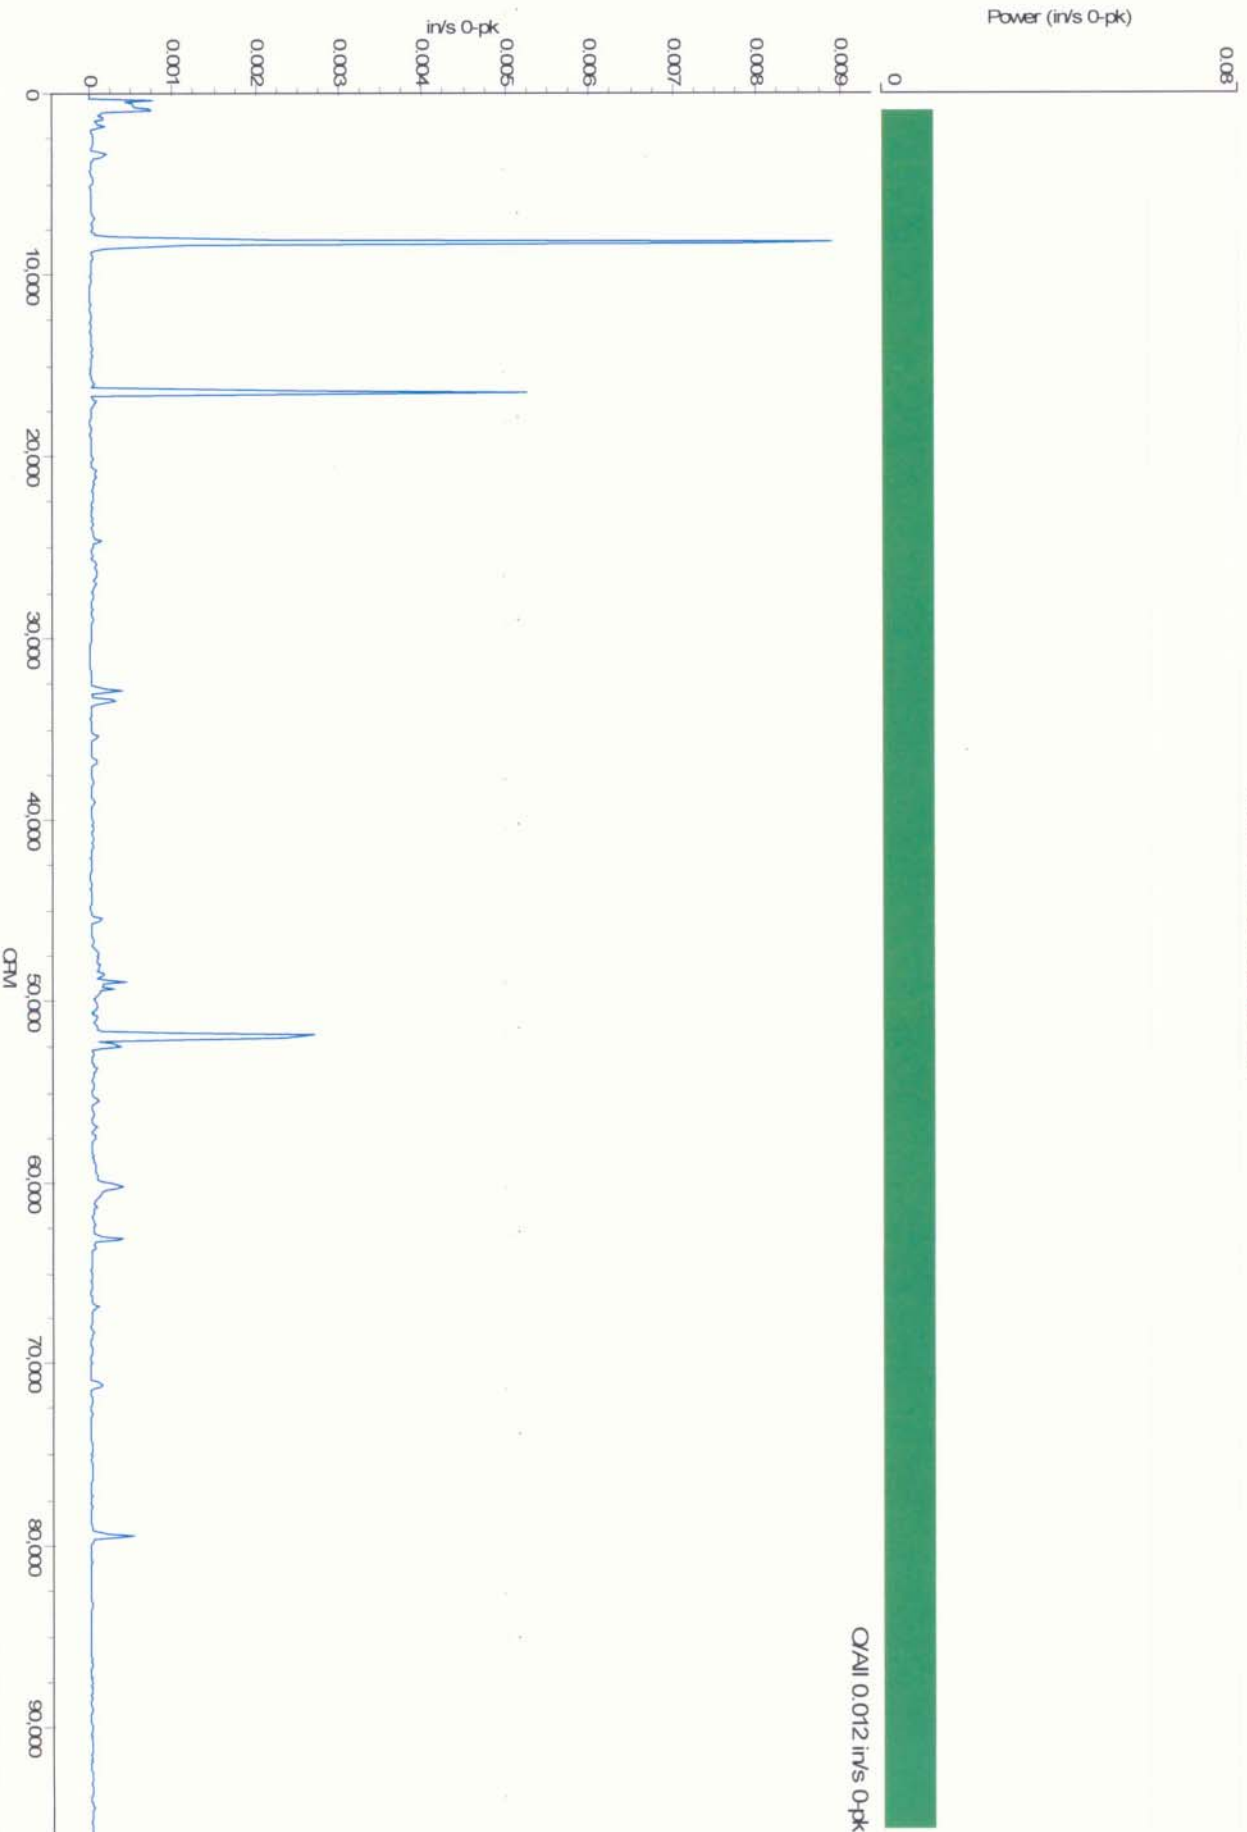
2460341 - Nose - Vertical - Vel Freq 96000 CPM  
5/29/2009 10:41:21 AM

5/29/2009 10:41:21 AM O/AI 0.012 in/s 0-pk

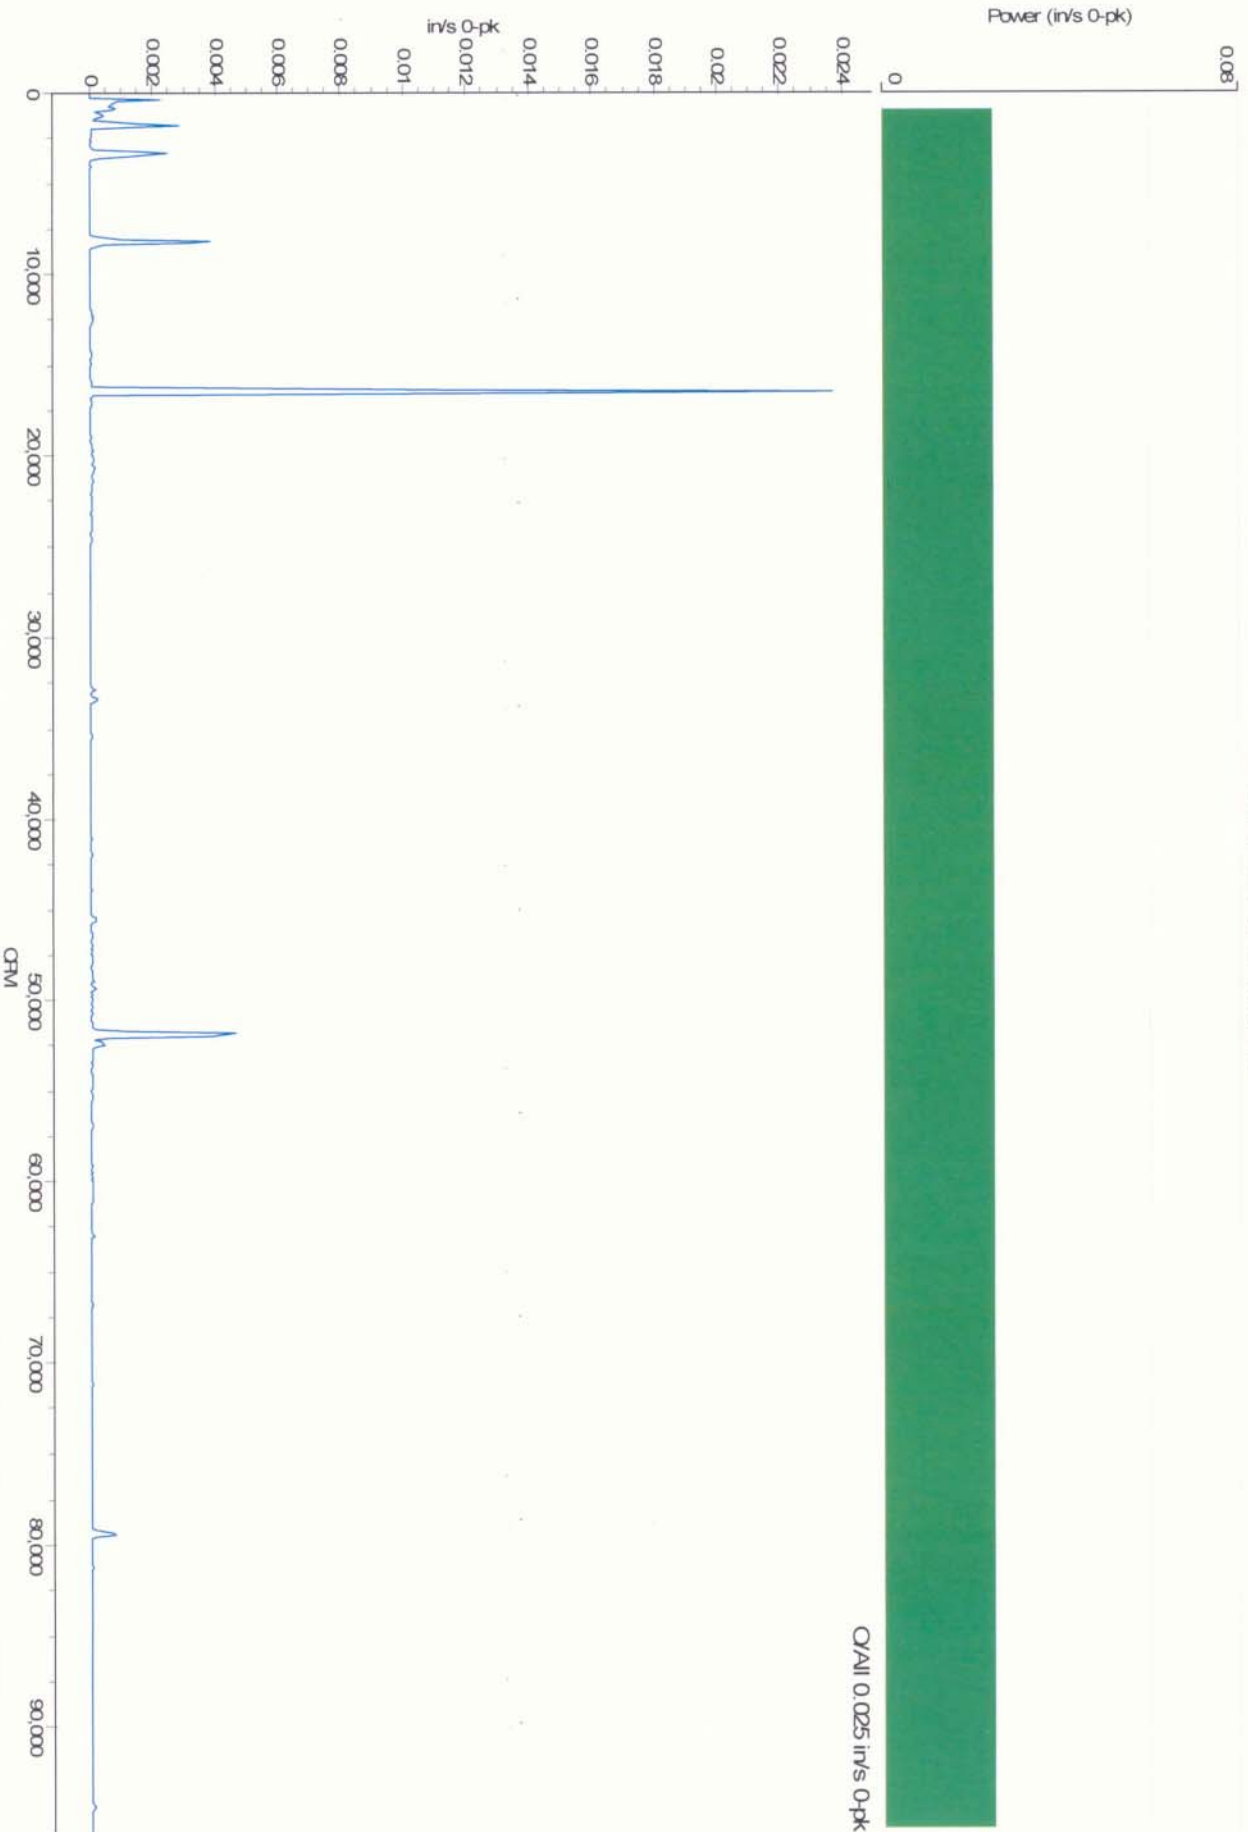
2460341 - Nose - Horizontal - Vel Freq 96000 CPM  
5/29/2009 10:42:00 AM

5/29/2009 10:42:00 AM O/All 0.025 in/s 0-pk

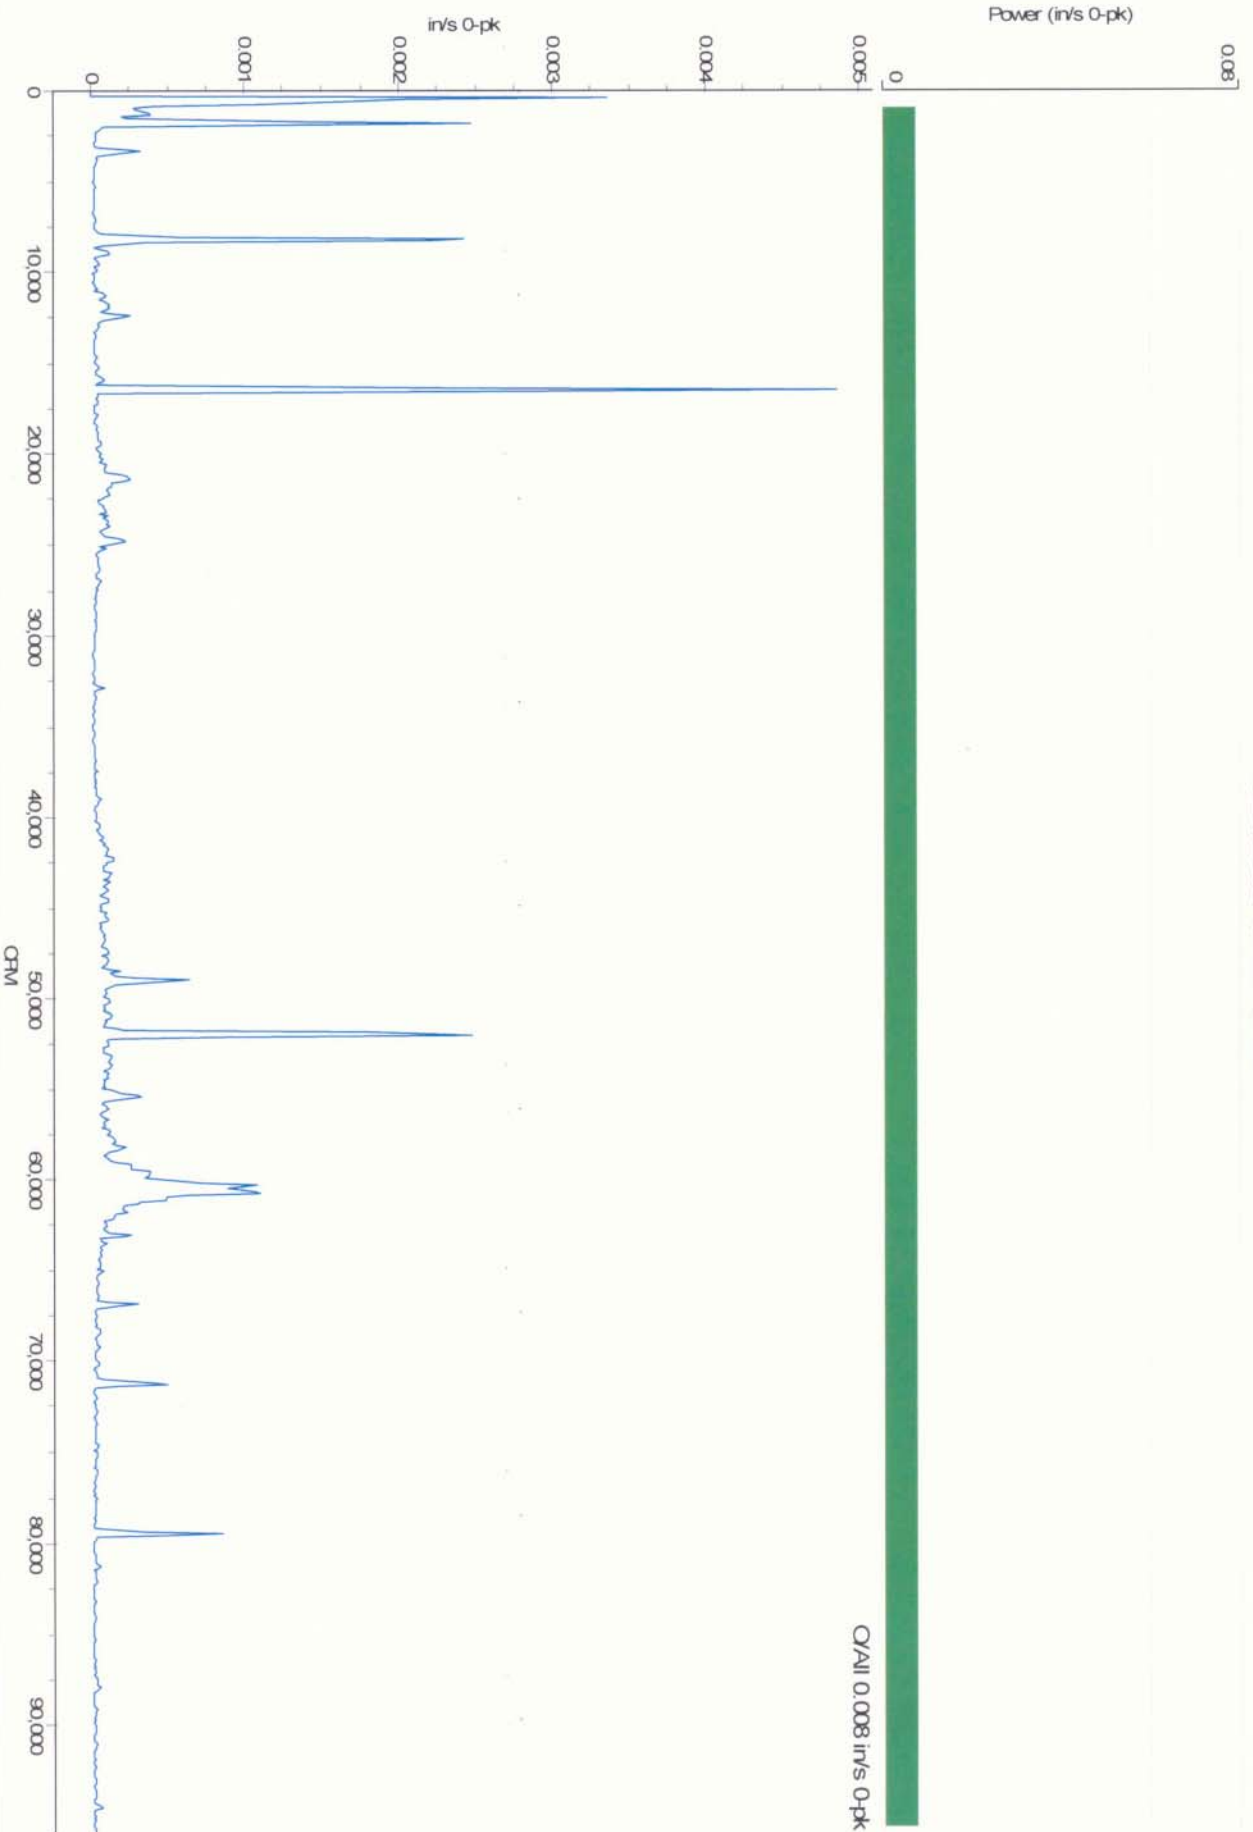
2460341 - Nose - Axial - Vel Freq 96000 CPM  
5/29/2009 10:42:16 AM

5/29/2009 10:42:16 AM Q/All 0.008 in/s 0-pk

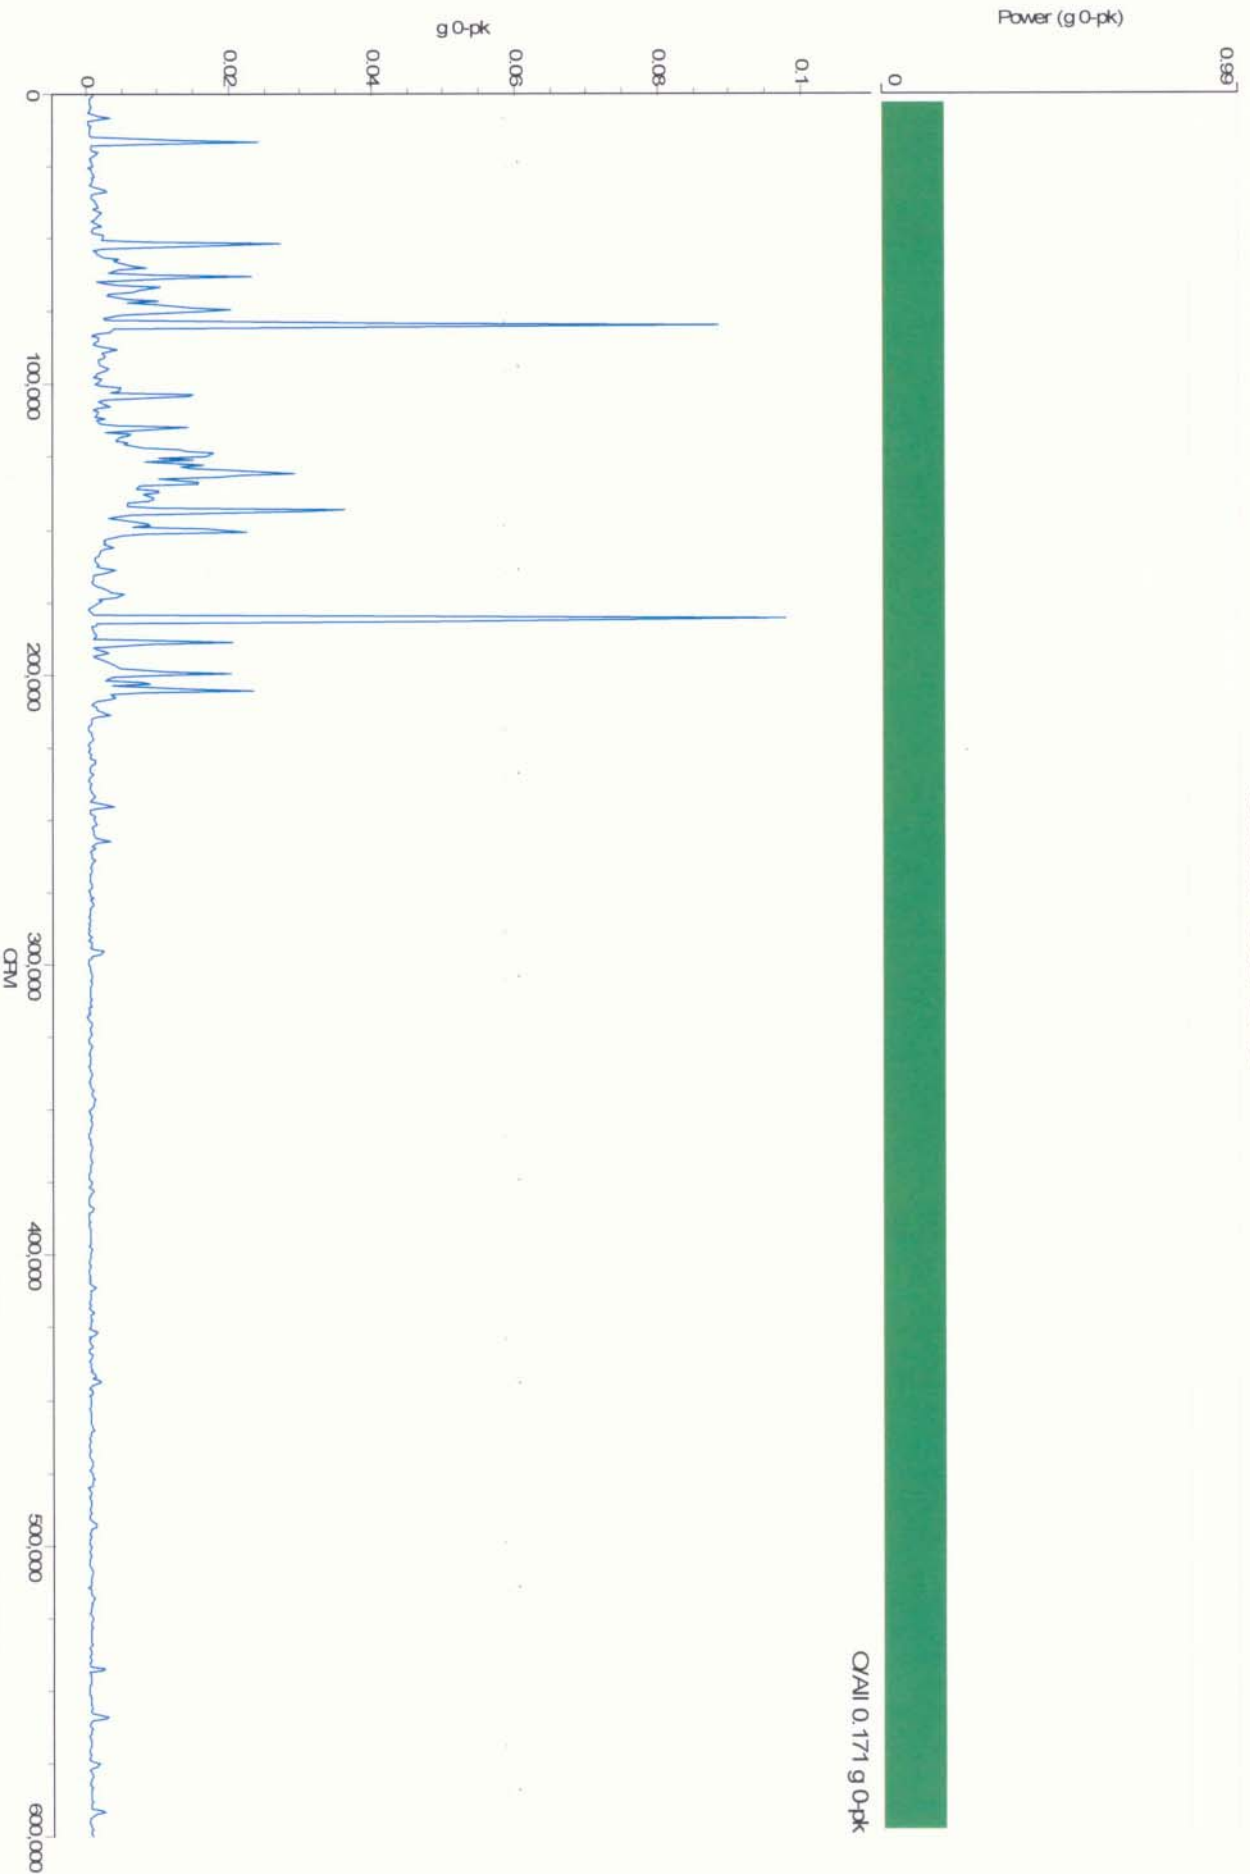
2460341 - Tail - Vertical - Acc Freq 600000 CPM  
5/29/2009 10:42:42 AM

5/29/2009 10:42:42 AM Q/AI 0.171 g 0-pk

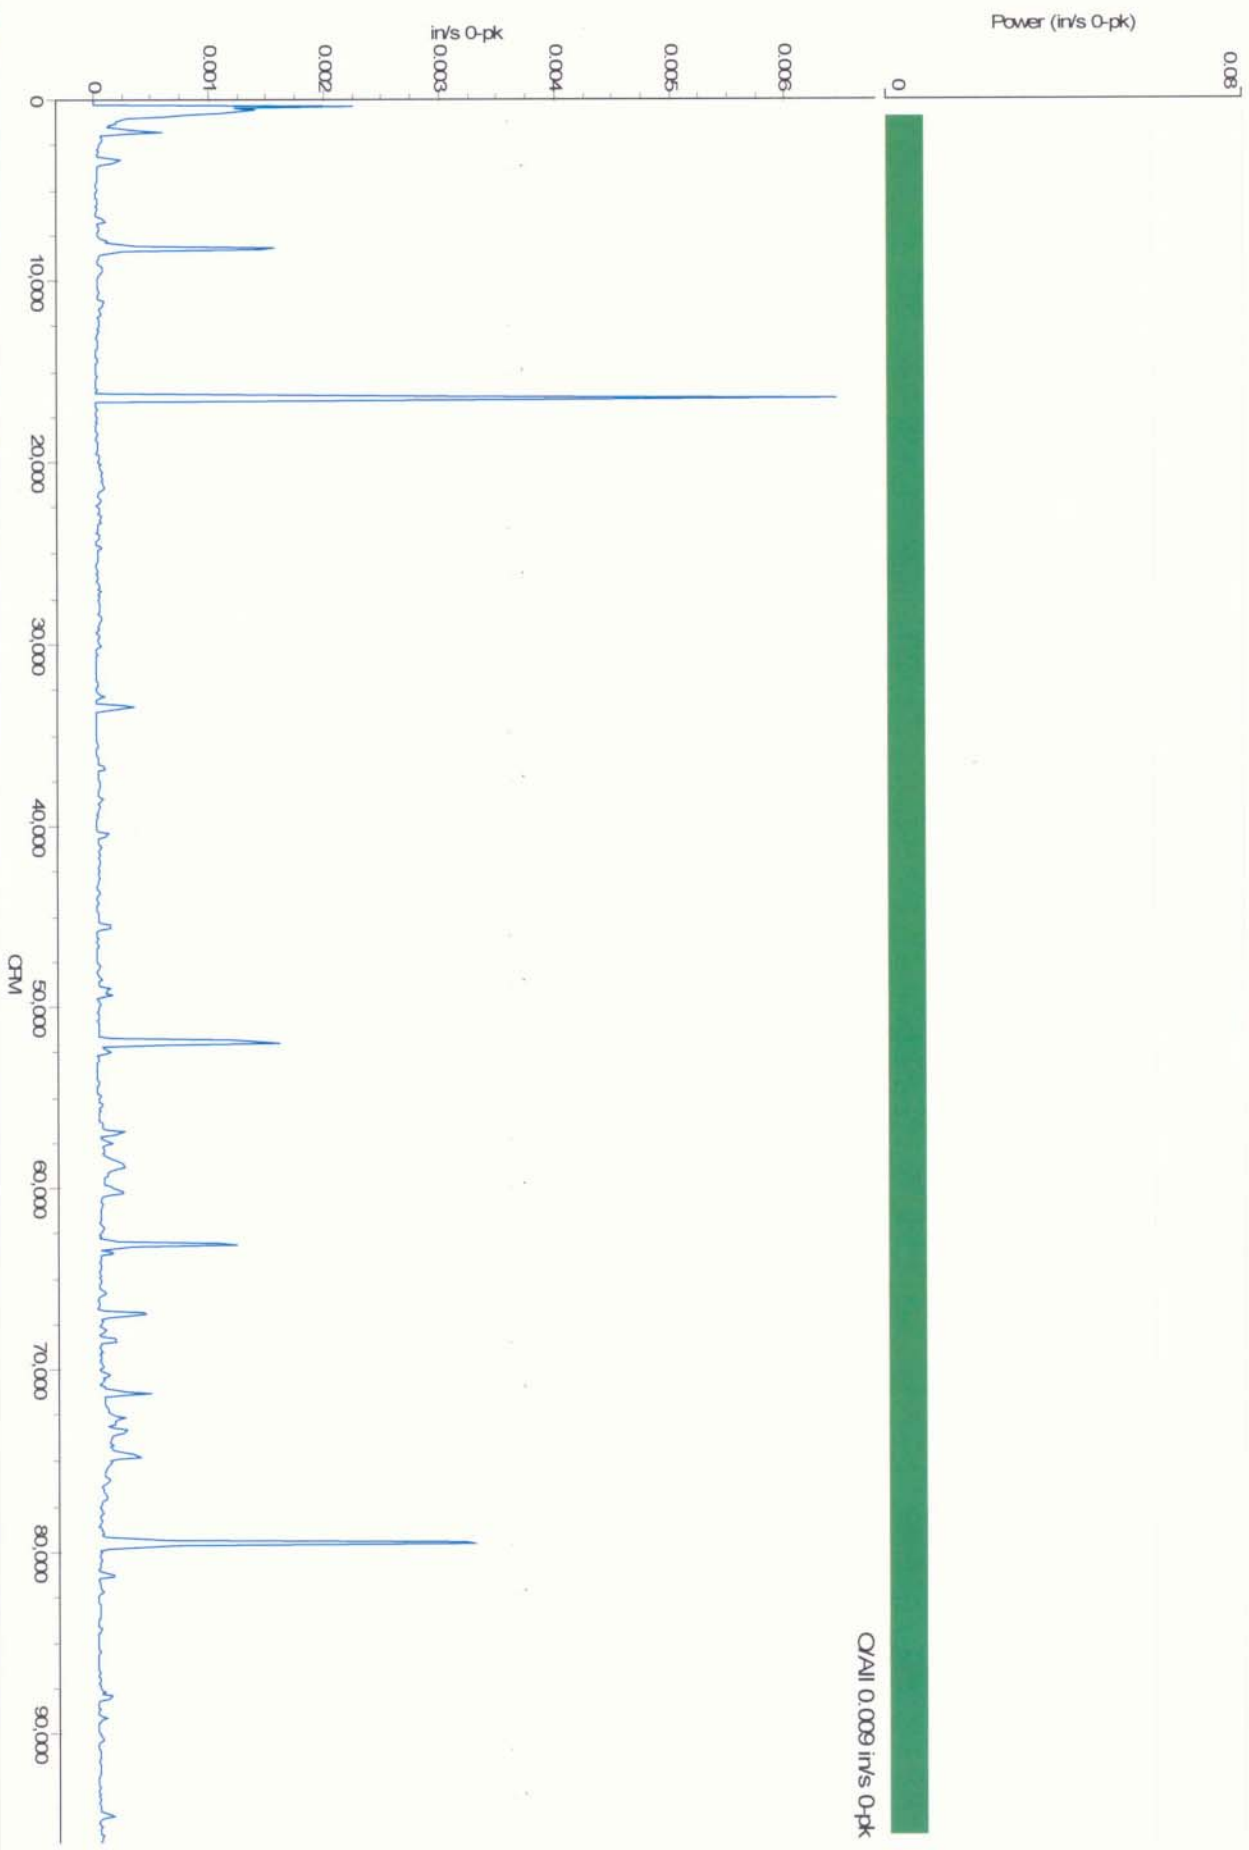
2460341 - Tail - Vertical - Vel Freq 96000 CPM  
5/29/2009 10:42:48 AM

5/29/2009 10:42:48 AM Q/All 0.009 in/s 0-pk
