## EVALUATION

**GMN V-100 Cartridge Spindle**

## FINAL INSPECTION REPORT

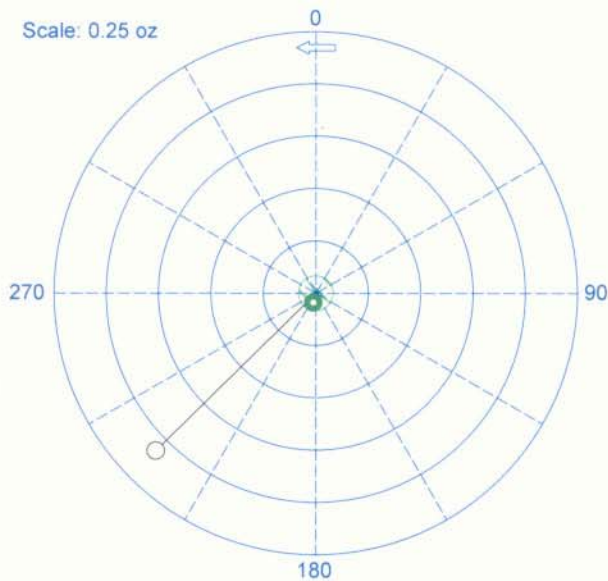
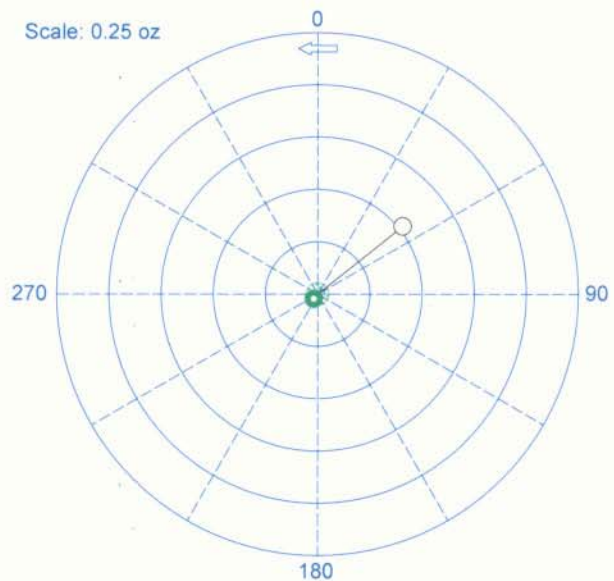
Left	Right
Correction Weight:	- 0.2143 oz at 225°	- 0.1040 oz at 52°
Unbalance:	0.250 oz-in	0.121 oz-in
	Reject (12.42 x Tol)	Reject (9.17 x Tol)

Left	Right
Correction Weight:	- 0.0095 oz at 196°	- 0.0060 oz at 220°
Unbalance:	0.011 oz-in	0.007 oz-in
	OK (0.55 x Tol)	OK (0.53 x Tol)

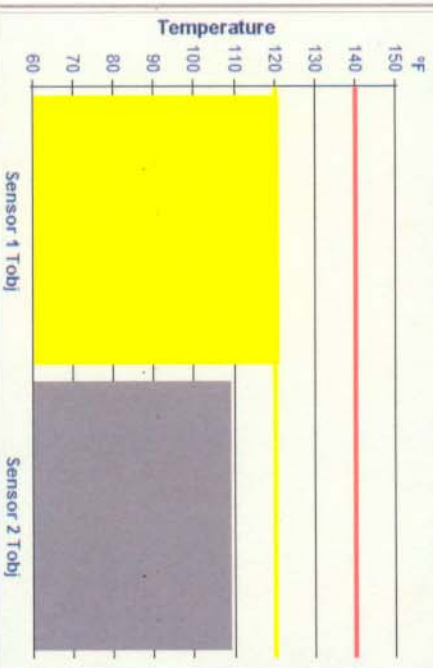
06-2-4A

Sensor 1 Tobj

120.8°F

Time	Sensor 1 Tobj	Sensor 2 Tobj
10:05:06		
	F	F
11:40:10 AM	118.4	101.6
11:45:10 AM	118.4	103.2
11:50:10 AM	120.4	106.0
11:55:10 AM	121.2	106.0
12:00:10 PM	121.4	107.2
12:05:10 PM	120.8	105.8
12:10:10 PM	122.0	108.2
12:15:10 PM	119.0	106.6
12:20:10 PM	120.8	106.8
